WYE MARSH

An Historical Perspective, Review of Habitat Management
and Recommendations for Future Action

Ducks Unlimited Canada
September 1995

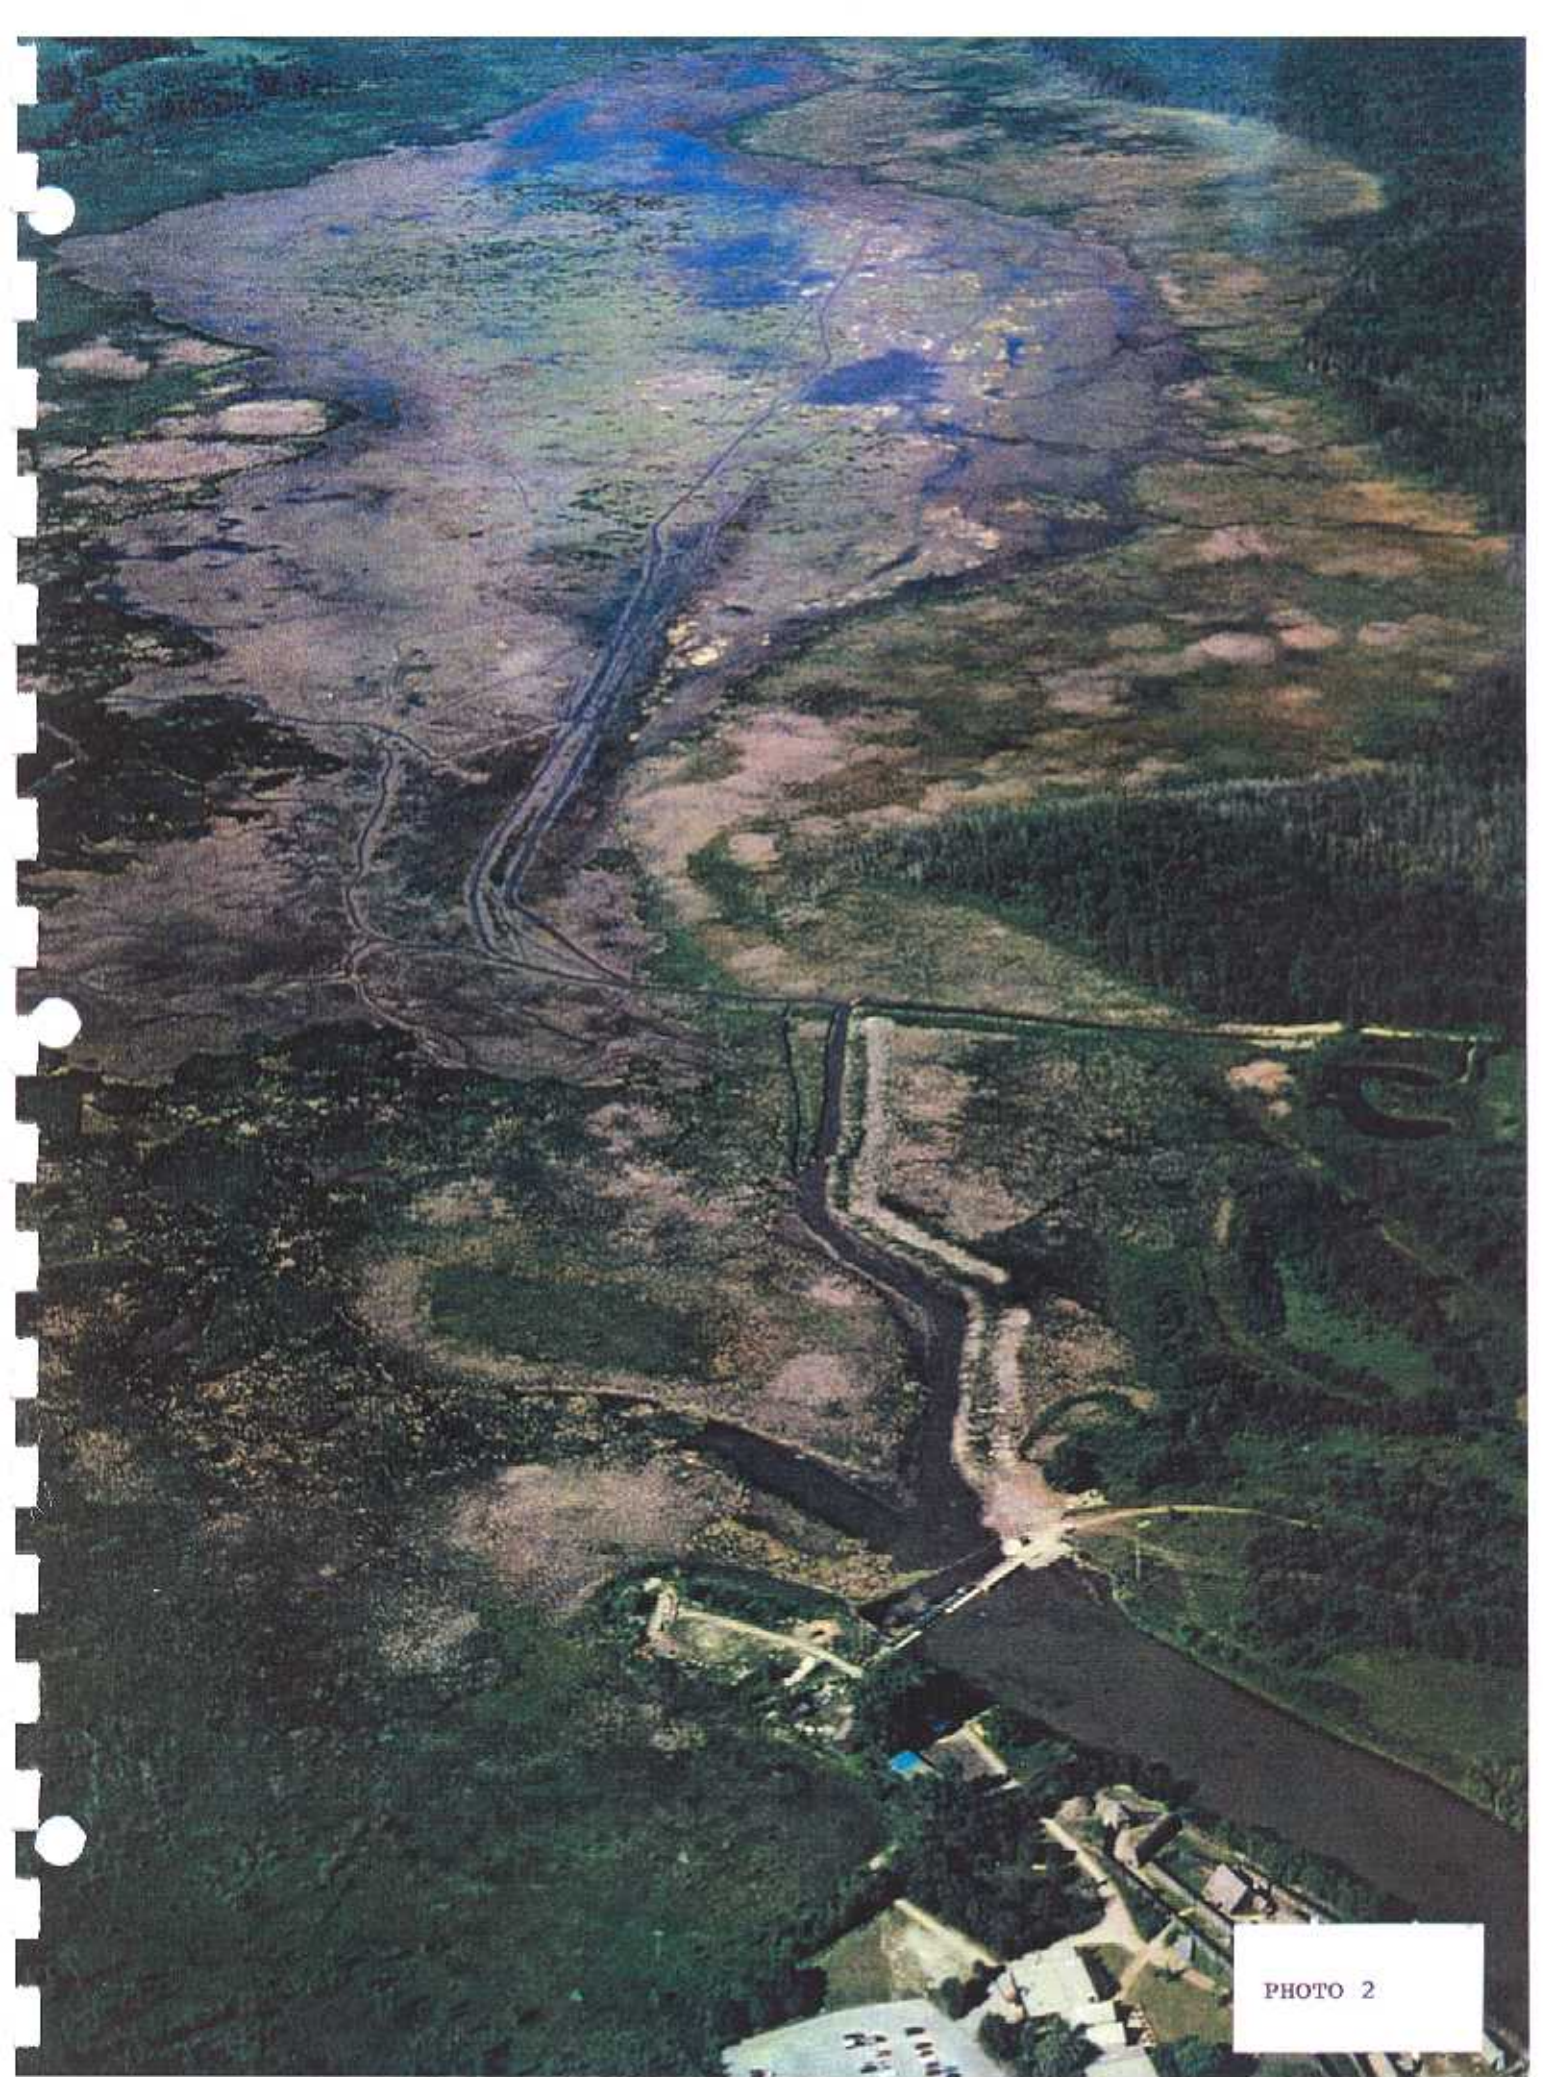
PHOTO 2

Modifications were made to the pump system in 1990 and the cookie cutter was used to improve drainage between the weir and the open water area of the marsh. Pumping was initiated May 18 and by late June the marsh was essentially surface dry (photo #2). Timely rains augmented moist substrate conditions and periods of hot weather triggered the germination and growth of emergents well into July (photo #3). The pumps were shut off August 21 and the basin allowed to refill via the Wye River. The co-dominant emergent plant species that germinated during the drawdown were softstem bulrush and common cattail (*Typha latifolia*), both of which are shallow water emergents. Extensive giant burreed (*Sparganium eurycarpum*), arrowhead (*Sagittaria* spp.), pickerel weed (*Pontederia cordata*), smartweed (*Polygonum* spp.) and spikerush (*Eleocharis* spp.) also germinated. As these species are essentially all adapted to shallow water conditions, a shallow reflood was undertaken to ensure the survival and establishment of this community. Deep flooding in contrast would have caused widespread plant die-off and a speedy return to open water conditions. In addition, deep flooding may have caused unstable mat conditions and in turn floating vegetation mats. The basin was exposed relatively late in the spring of 1990, resulting in a shortened growing season and thus a reduction in the growth establishment period of the plants. Increasing water levels on emergent vegetation that is not fully developed can cause plant die-off. Photo #4 shows the basin in September of 1990 under partial reflood conditions.

Photo 1	Open marsh phase of Mud Lake. Vegetation is confined primarily to the floating mat fringe surrounding the lake. Pre-management photo taken in August, 1988.
Photo 2	Drawdown of Mud Lake to expose the substrate. Water removal delayed somewhat due to technical problems with the pumps. Photo taken in early June, 1990.
Photo 3	Drawdown of Mud Lake. Vegetation has germinated over much of the basin but growth is delayed. Photo taken in mid-July, 1990.
Photo 4	Partial reflood of Mud Lake following the drawdown earlier in the year. Vegetation distribution is excellent however plant robustness less than desired due to late dewatering. Photo taken in mid-September, 1990.
Photo 5	Year after Mud Lake was drawdown. Water levels are relatively low to encourage emergent vegetation to further establish. Photo taken in late May 1991.
Photo 6	Mud Lake 2 years after drawdown. Shallow water emergents are well established. Photo taken in mid-September, 1992.

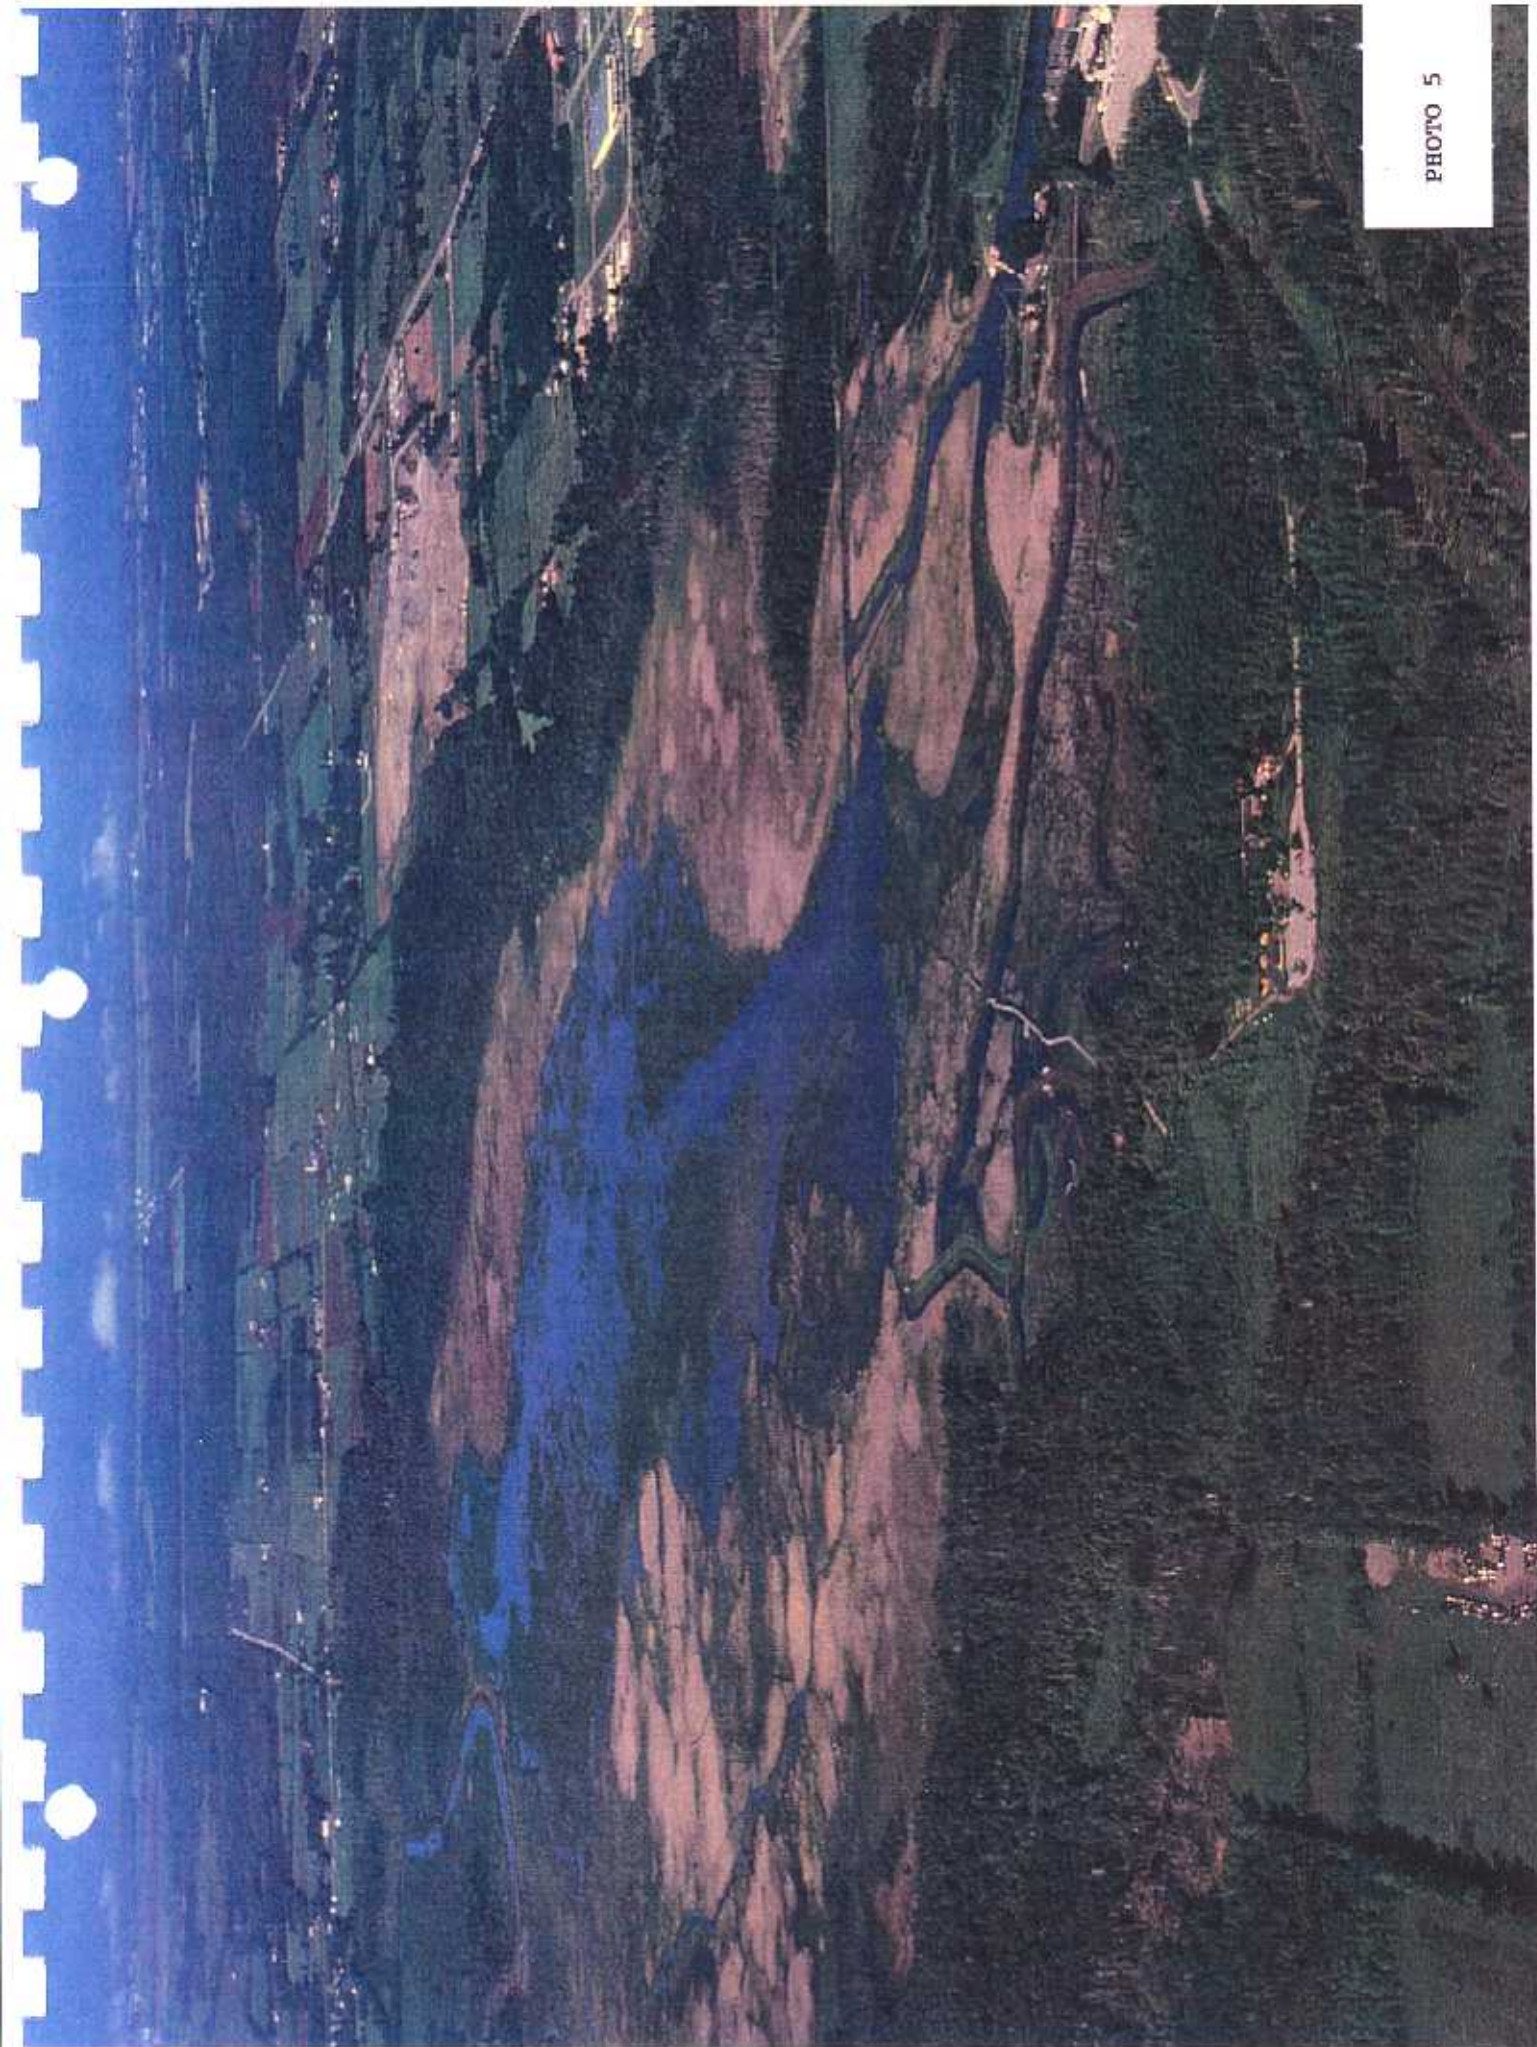
PHOTO 5

The primary management objectives in 1991 was to ensure that newly established plant communities remained healthy. This was accomplished by holding water depths low at an average depth of 0.5 m. Vegetation response by mid-May was excellent (photo #5). By August, 85% of the former open water area was revegetated with robust shallow water emergents. Softstem bulrush
